HUDSON RIVER BASIN
CAMP HARRIMAN DAM
GREENE COUNTY, NEW YORK
INVENTORY NO. 552

PHASE I INSPECTION REPORT
NATIONAL DAM SAFETY PROGRAM

HUDSON RIVER BASIN
CAMP HARRIMAN DAM
INVENTORY NO. 552
PHASE I INSPECTION REPORT

Name of Dam	CAMP HARRIMAN DAM (I.D. NO. 552)
State Located:	NEW YORK
County Located:	GREENE COUNTY
Stream:	EAST KILL, SCHOHARIE CREEK
Date of Inspection:	AUGUST 30, 1978

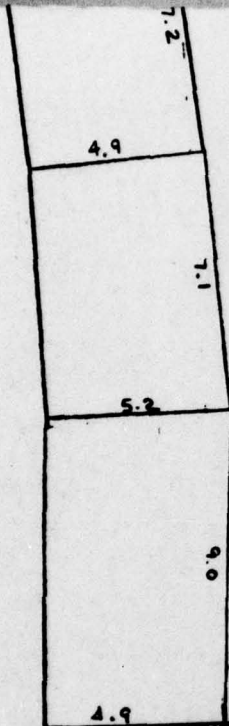
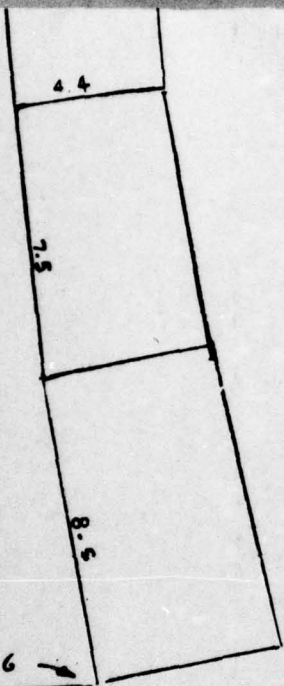
PLAN of MAIN SPILLWAY
SCALE 1" = 5'0"

CONCRETE APRON
BADLY ERODED

- Repair and maintain pavement on the dam crest
- Repair the main spillway
- Fill cavities under the auxiliary spillway
- Maintain the emergency relief channel in a clear and operable condition for a full 100 ft width
